Prepared for:  
The Kable's Mill Owners Association  
Bellbrook, Ohio  
Project No. 5555-219

September 22, 2017  
By Kipcon Great Lakes, LLC

## Kable's Mill Owners Association Component Schedule Summary of Replacement Reserve Needs

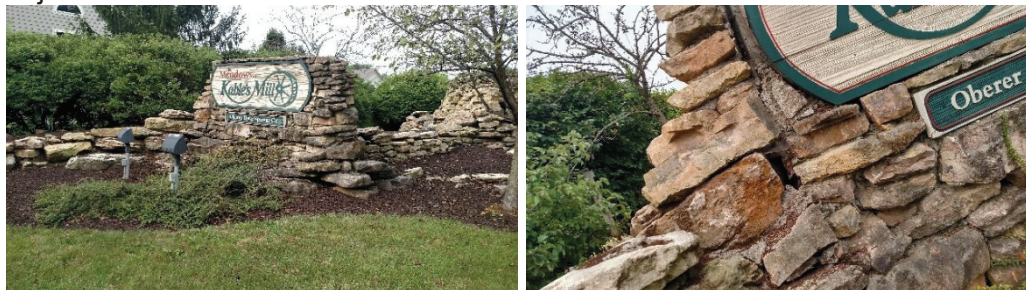
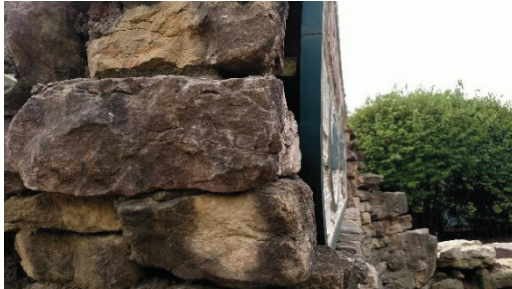
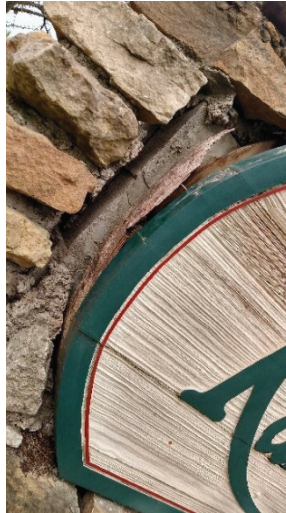
- Entry Monument I: The Association maintains 2 entry monuments. The larger one being approximately 80LF of stacked stone. A wood sign is affixed to the stone stack with mortar. The site is lit by 4 in ground spot lights and there is a junction power box at the location. The stones were loose, the sign rotted and falling away from the stone and the mortar was observed in overall poor condition. Replacement is recommended. It is in the report budget for 2018 but if it is done before the end of 2017 adjustments can be made.

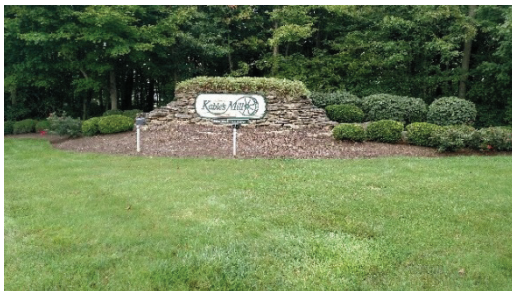
2. Monument II: The second smaller monument is located at the entry to the neighborhood on Kable's Mill Dr. This monument is approximately 45LF and was observed to be in good condition at the time of the inspection. Pricing includes the 2 in ground spot lights,

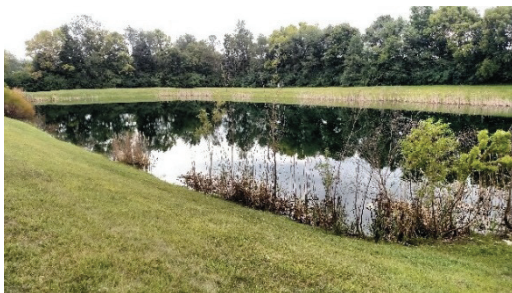
3. Pond I: The 4 retention ponds have been given separate entries for ease of budgeting, the actual dredging dates are flexible and can be adjusted to fit the Association's budget. This pond located well off Settler's Bay had some vegetation overgrowth, and shoreline erosion and some algae was noted.

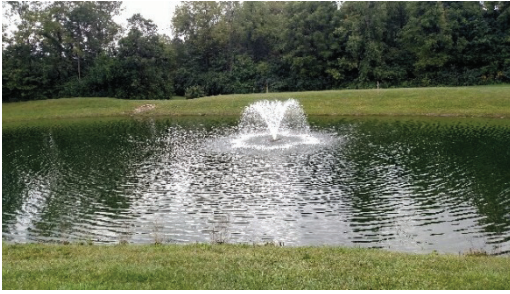
4. Pond II: This pond is located right off the street at Settler's Bay and is equipped with a fountain (aerator), as well as a dedicated electric utility box. The pond was without riprap, had some debris with moderate shoreline erosion.

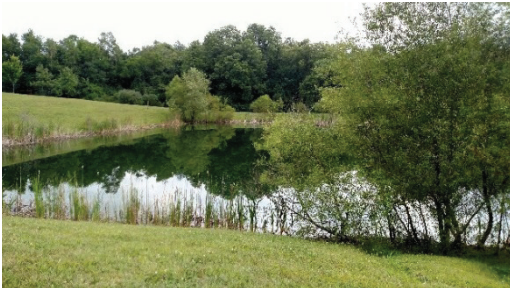
5. Pond III: This pond has a large figure 8 shaped configuration, and is located off street, behind Seton Hill/North Church Rd. It was noted to have at least one significant tree growing in the water, vegetation overgrowth and moderate erosion at the shoreline.

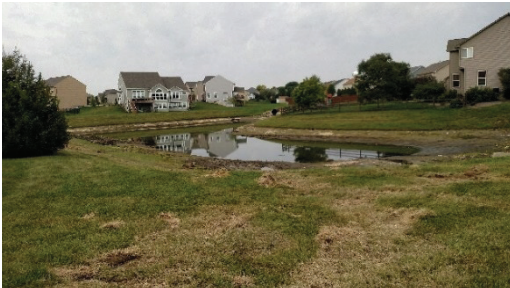
6. Pond IV: This pond is located on the street on Seton Hill. The pond has been dredged in 2017, and looks to be in good condition.

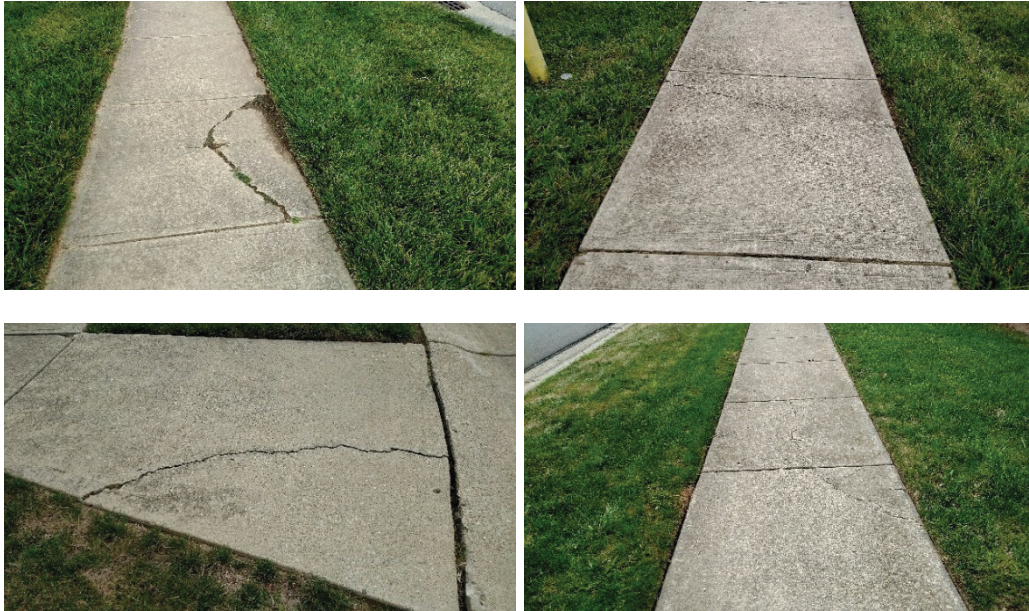
8. Sidewalk Phase I: For budgeting purposes and replacement projection the sidewalks have been grouped into phases. Since it is unlikely that more than 50% of the walk will ever need to be replaced at one time the total square footage has been decreased by ½. The walks in this phase represent the interior walks for which the Association is responsible primarily at or near the ponds. There are a few squares of walk in need of repair or replacement and these can be done as needed within these budget parameters. Besides cracks or sunken squares there are also expansion joints missing that should be replaced whenever work is scheduled in the future.

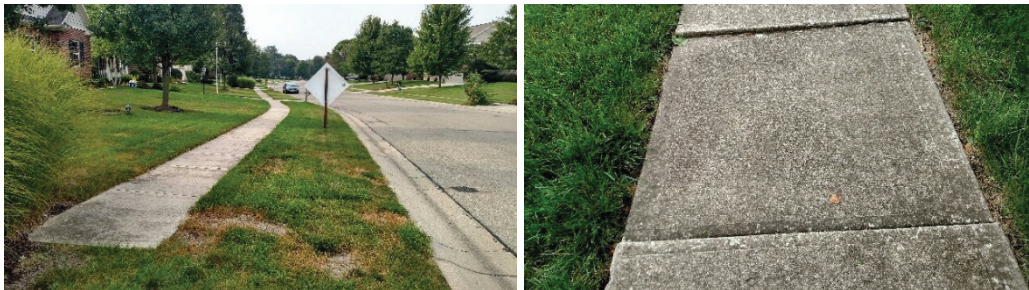
9. Sidewalks Phase II: These are categorized as the entry area walks from the entry monuments around to the areas where the homes begin. These areas have also been reduced by 50%. There is a square at the Seton Hill entry that has settled to the extent it has become a trip hazard and should be replaced or mud jacked for liability purposes.

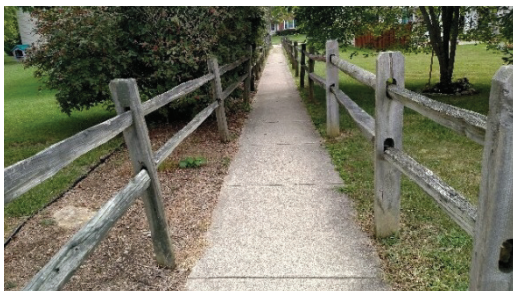
10. Sidewalk with School Access: This walk was segregated as it is uniquely situated and may have requirements for replacement. Some cracks were also noted here.

11. Split Rail Fence: The split rail fence shown above that borders the walk to the school is weathered but in adequate condition. It was noted that replacement rail(s) have been inserted. This manner of replacement could continue as needed for the present.

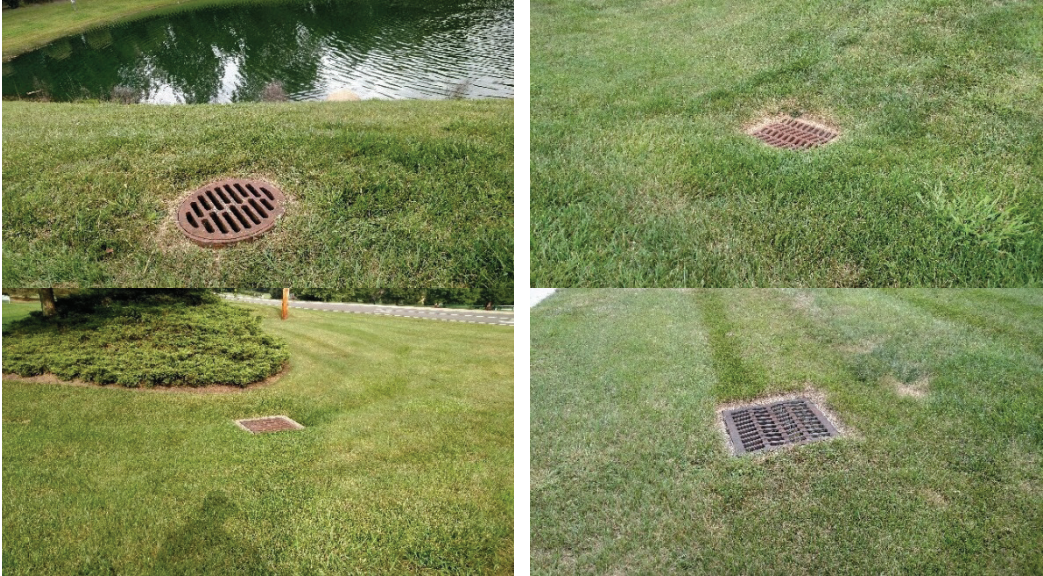
13. Catch Basins: There are four (4) catch basins located in the landscaped areas at or near the ponds for drainage assistance. Any basin not set a grade level should be adjusted appropriately.
